COMPENDIUM OF POST-FAILURE ANALYSIS TECHNIQUES
FOR COMPOSITE MATERIALS

RAY GROVE, BRIAN SMITH
BOEING MILITARY AIRPLANE COMPANY
P. O. BOX 3707
M/S 73-43
SEATTLE, WASHINGTON 98124

JANUARY 1987

INTERIM REPORT FOR PERIOD JULY 1984 - NOVEMBER 1986

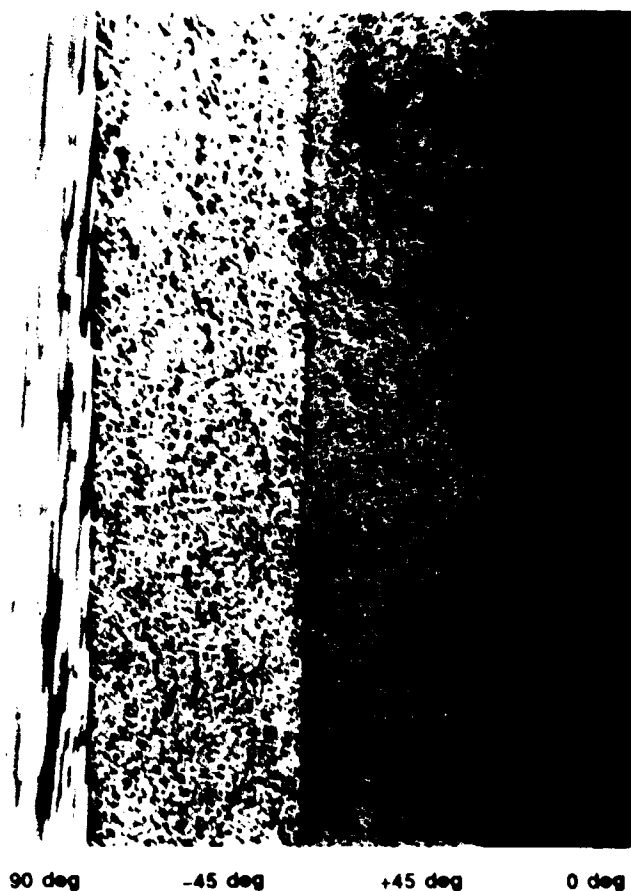
Figure 3-5. Identification of Ply Orientation by
Fiber End Shape and Ovality

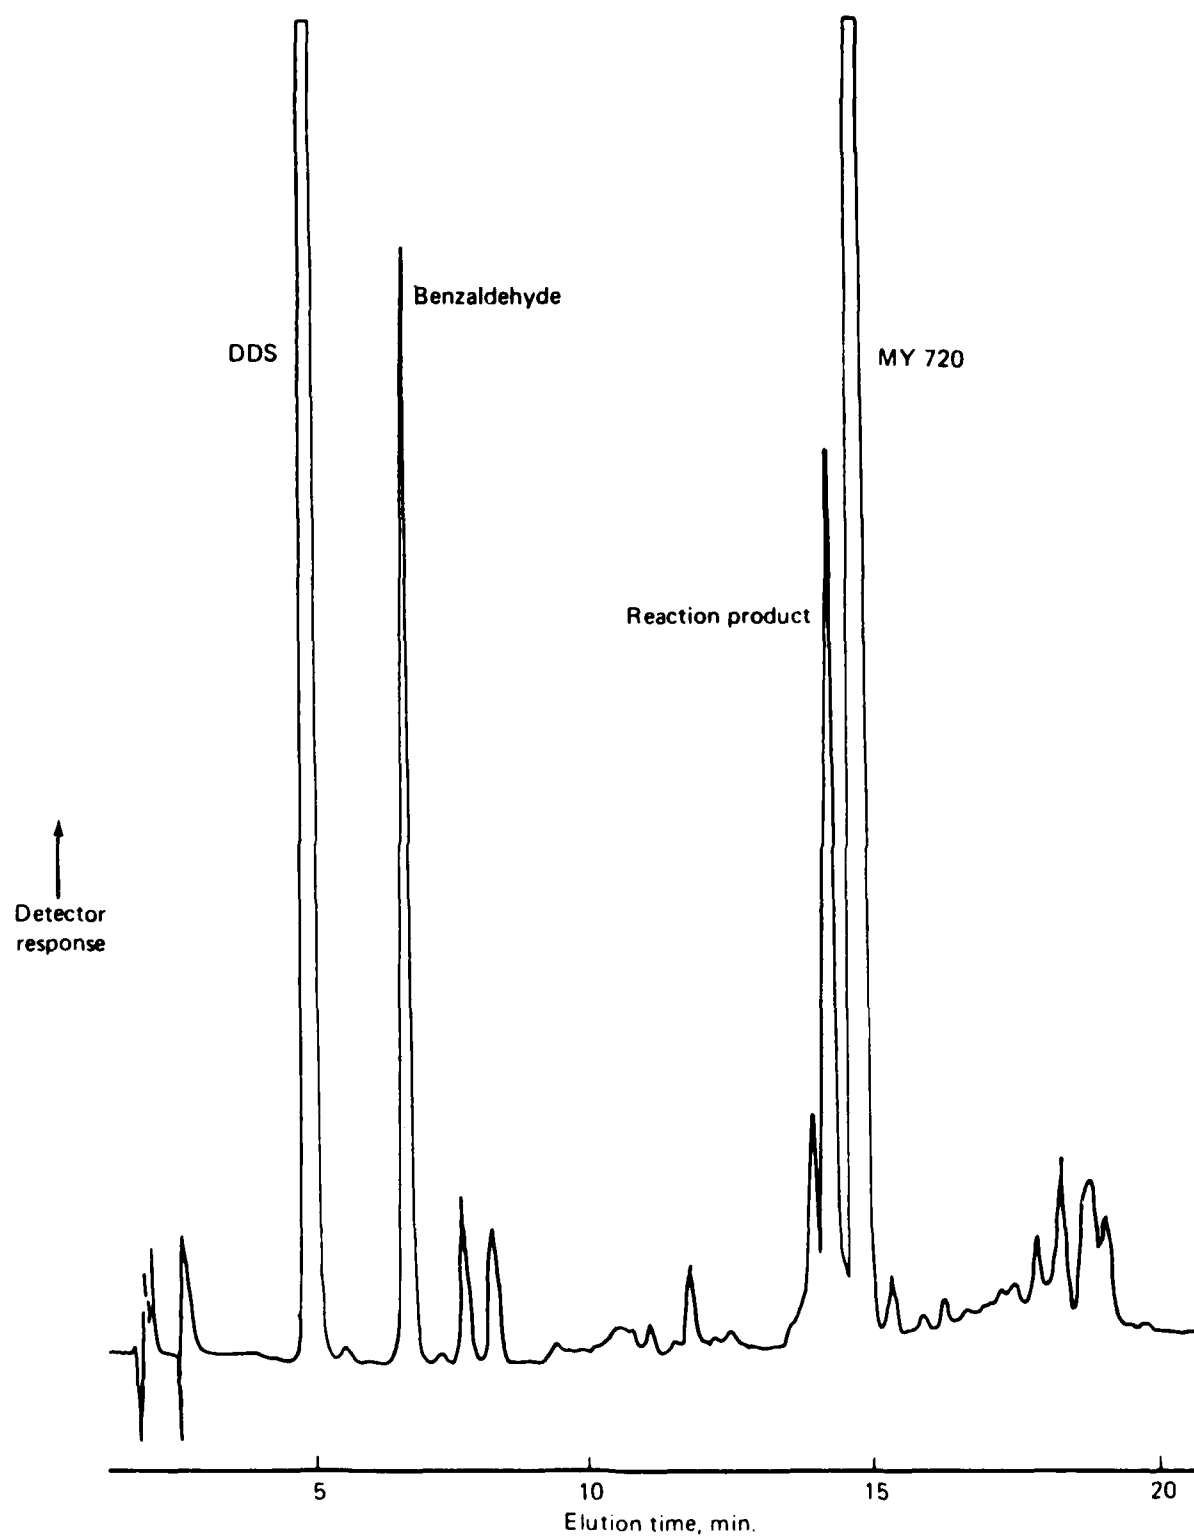
Figure 3-9. LC Chromatogram of Narmco Resin Matrix Showing Major Peak Assignment

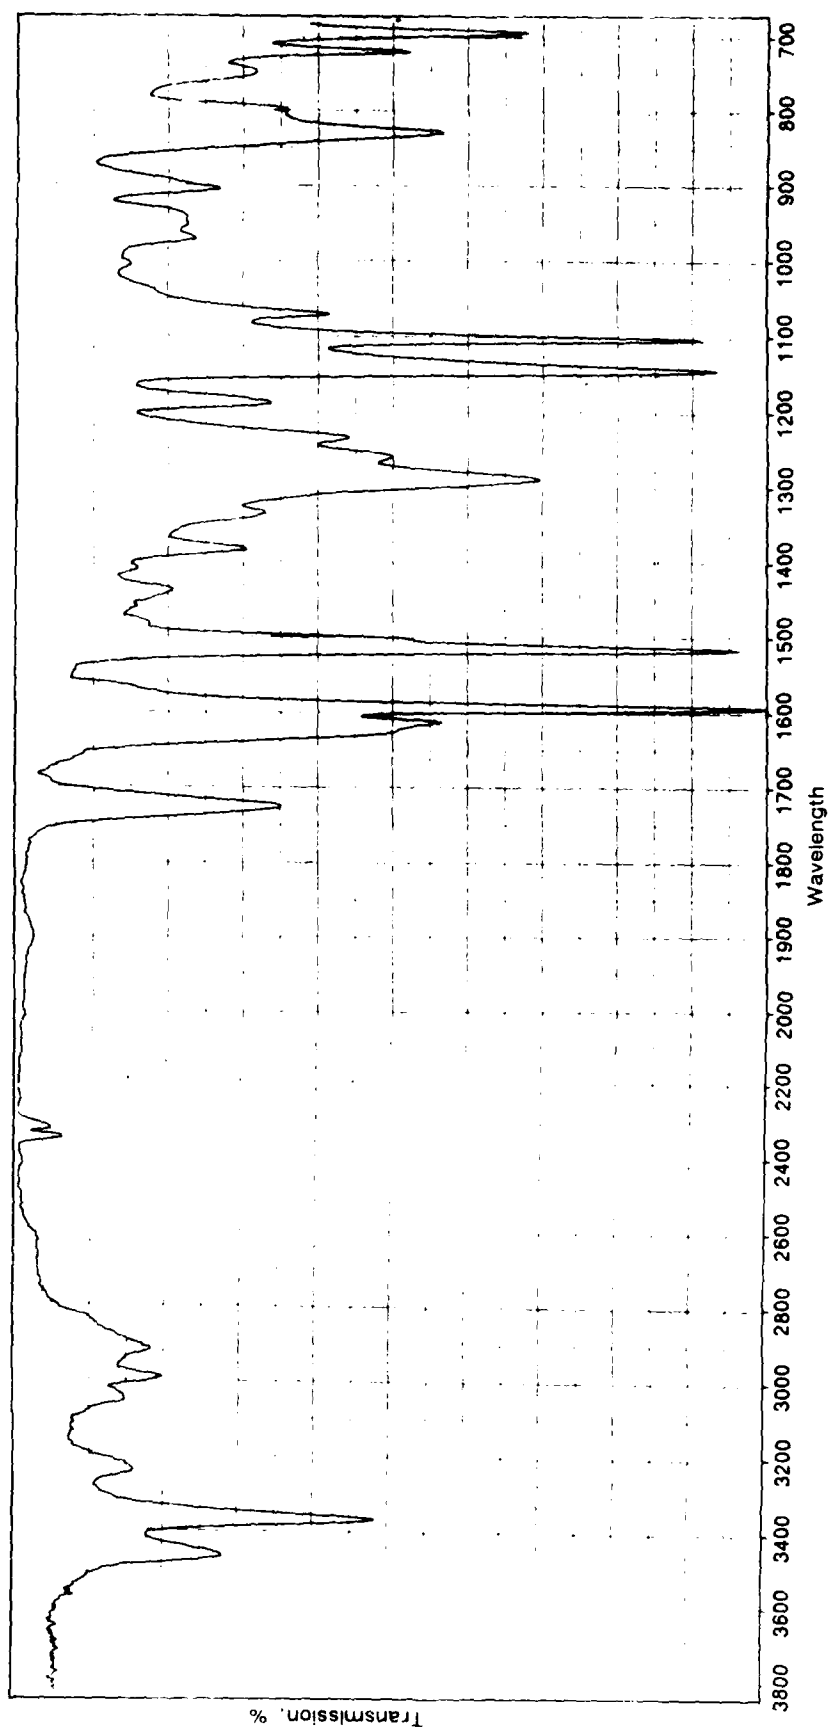
Figure 3-10 Standard IR Spectrum of a Commercial Epoxy Resin Formulation

epoxy spectrum acquired from the supplier or on a previous batch of material. The spectrum is examined for contaminants (additional peaks) or gross formulation changes (changes in the relative peak ratios). An example of a standard epoxy resin spectrum is shown in Figure 3-10. If a deviation from the standard spectrum is observed, then each subcomponent should be quantified and compared to standard formulation quantities. Quantitation methods for the curing agent and catalyst are considered below.

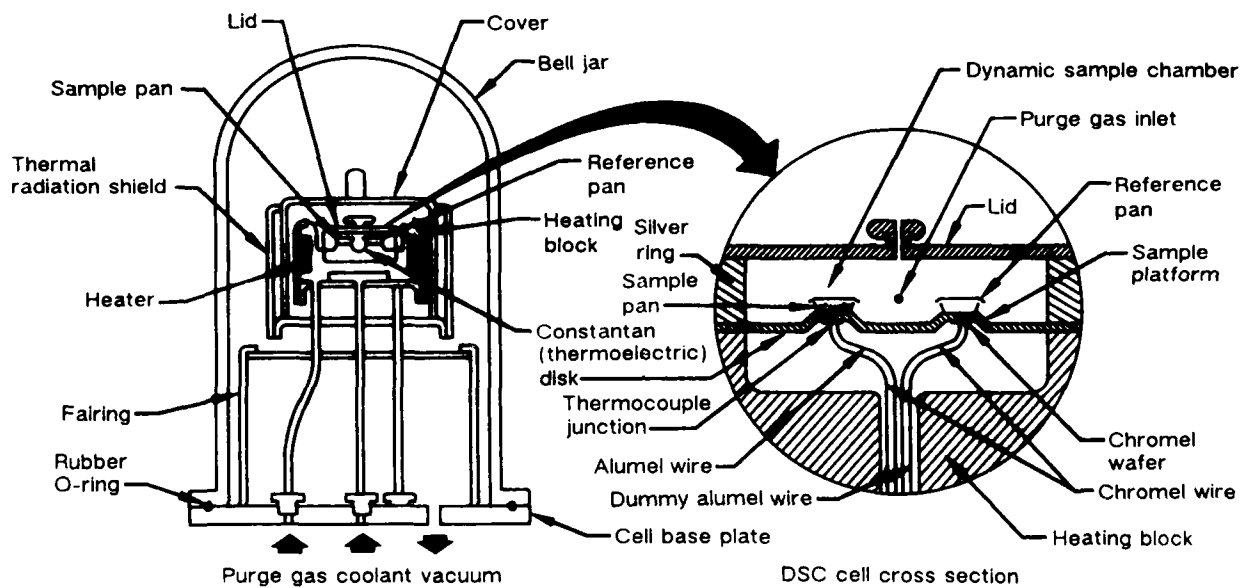
Figure 3-11. Cross-Sectional Diagram of the DSC Cell Used by Du Pont DSC Module

A typical DSC cell is shown in Figure 3-11. The sample pan and reference pan are placed in the cell. An inert atmosphere of nitrogen is then introduced into the test chamber. Heat is transferred to the pans through the sample platforms and heat flow is monitored by thermocouples. Generally, prepreg sample sizes of approximately 10 mg are used for DSC experiments depending on the size of the sample pan used. Low heating rates of about 2 to 5°C/minute are best to separate the various reaction peaks. Heat flow versus

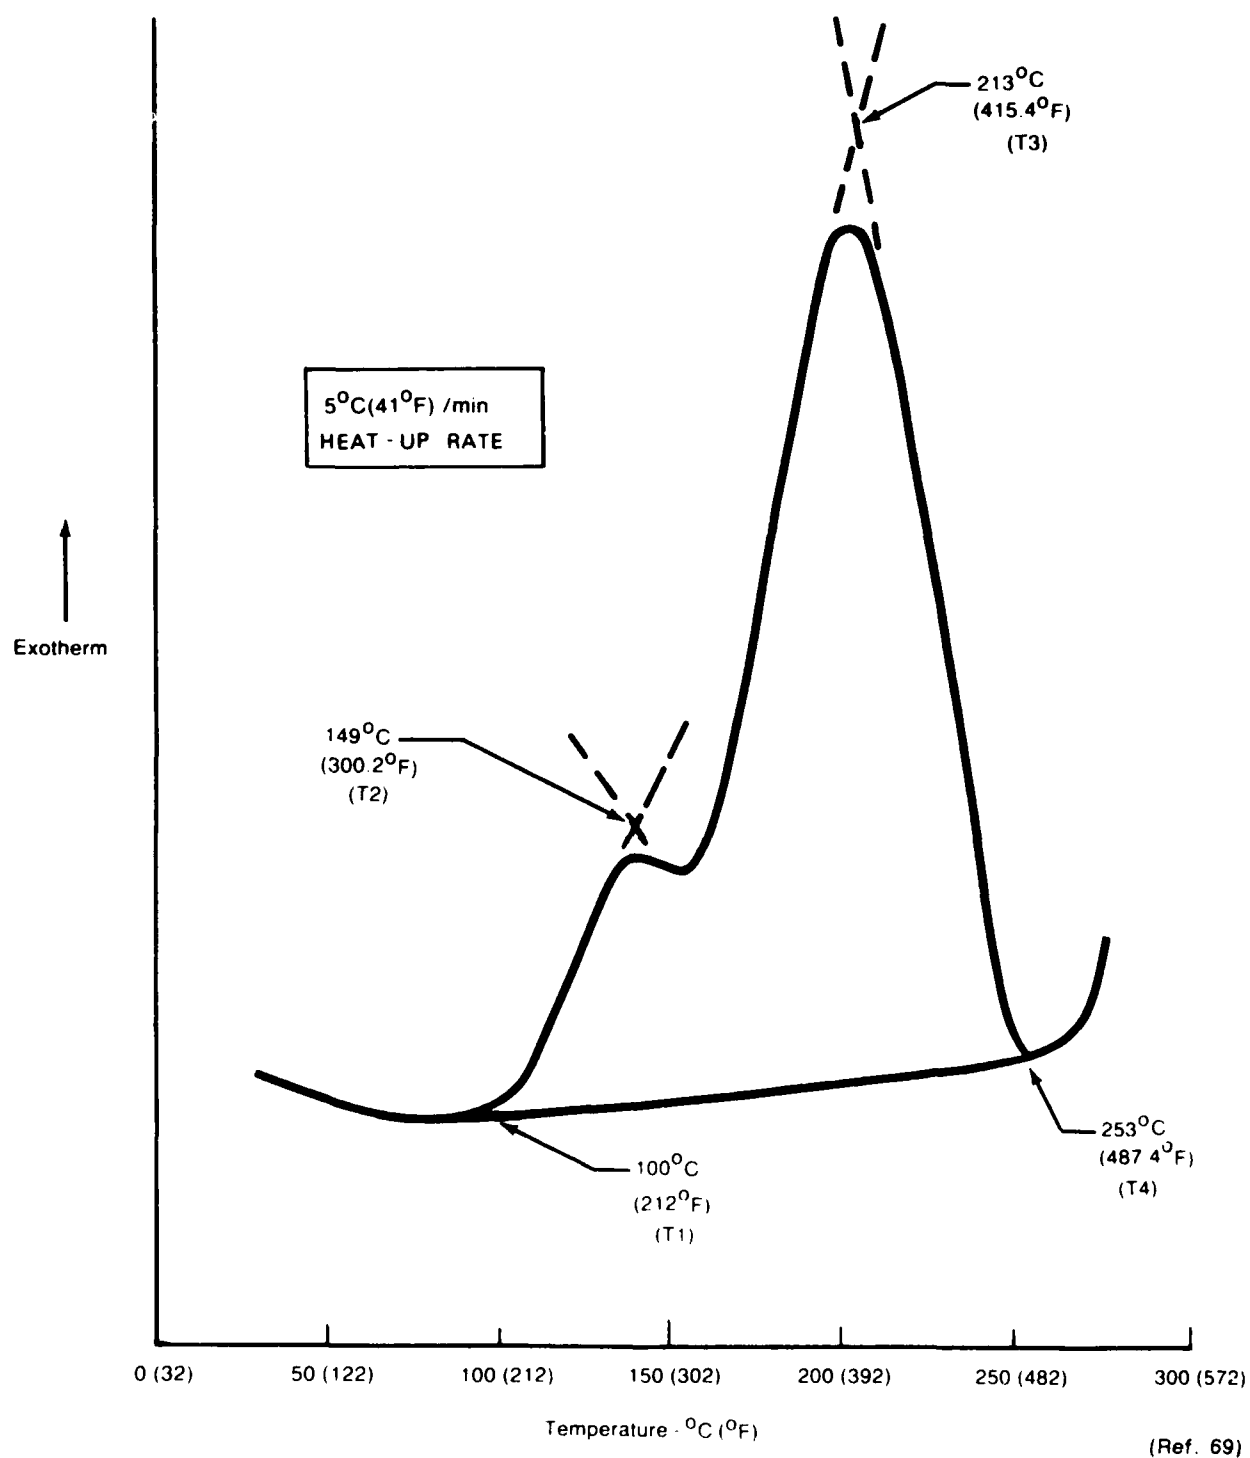
Figure 3-12. DSC Thermogram for 3501-6 Resin

A DSC thermogram for the Hercules 3501-6 resin system is shown in Figure 3-12. Exotherm peaks are observed at two temperatures (149°C and 213°C). The lower temperature peak is attributed to the catalyzed cure reactions while the higher temperature peak is attributed to the uncatalyzed cure reactions. The total heat of reaction (the area between the thermogram peaks and baseline T1 to T4), the relative peak size, and reaction temperature can identify resin constituents. Comparison to a standard thermogram can identify a particular resin system.

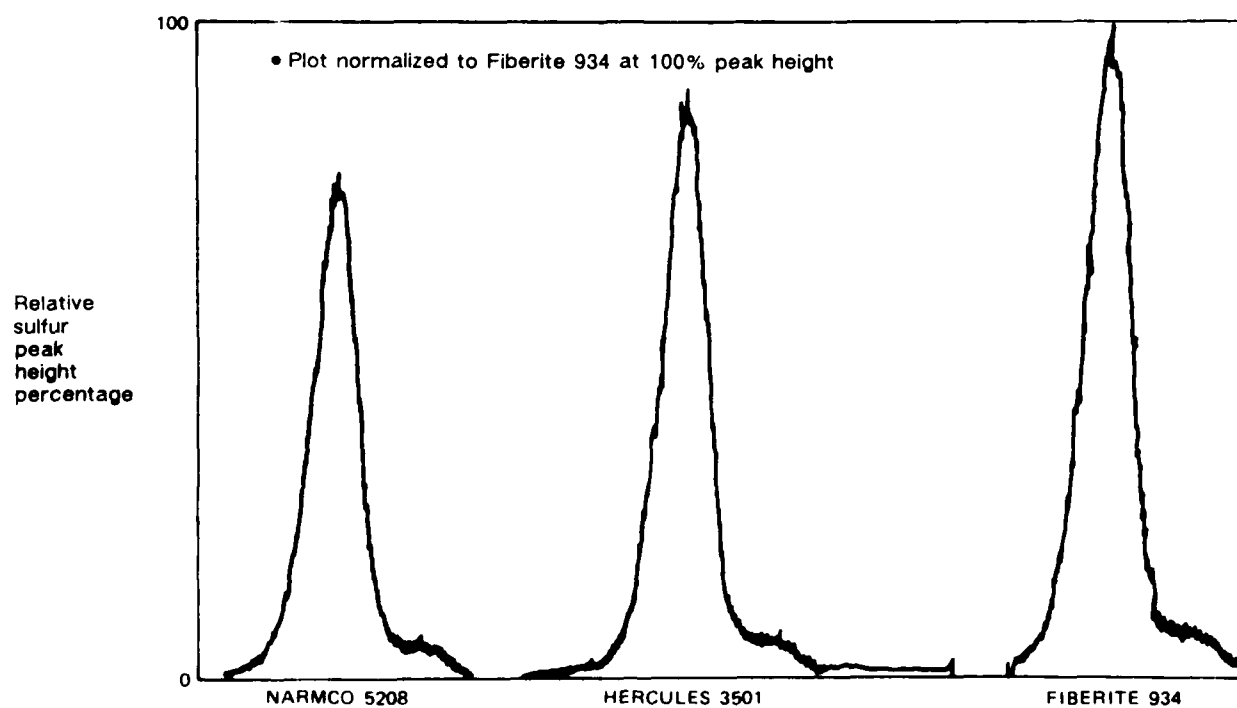
Figure 3-13. Sample Fingerprinting of Various Systems by Way of X-Ray Fluorescence

X-ray Fluorescence Spectroscopy (XRF)—XRF can be used qualitatively or quantitatively to determine the amount of DDS curing agent in an epoxy prepreg extract by quantifying the amount of sulfur present. XRF measurements are initiated when a formulation change is suspected, based on HPLC or IR evaluation. The XRF determination is based on the emission of X-rays characteristic of sulfur (0.537216 nm) when the sample is irradiated with an X-ray source. The intensity of X-ray emission is proportional to the sulfur concentration. An example of a qualitative comparison of different epoxy resin systems is given in Figure 3-13.

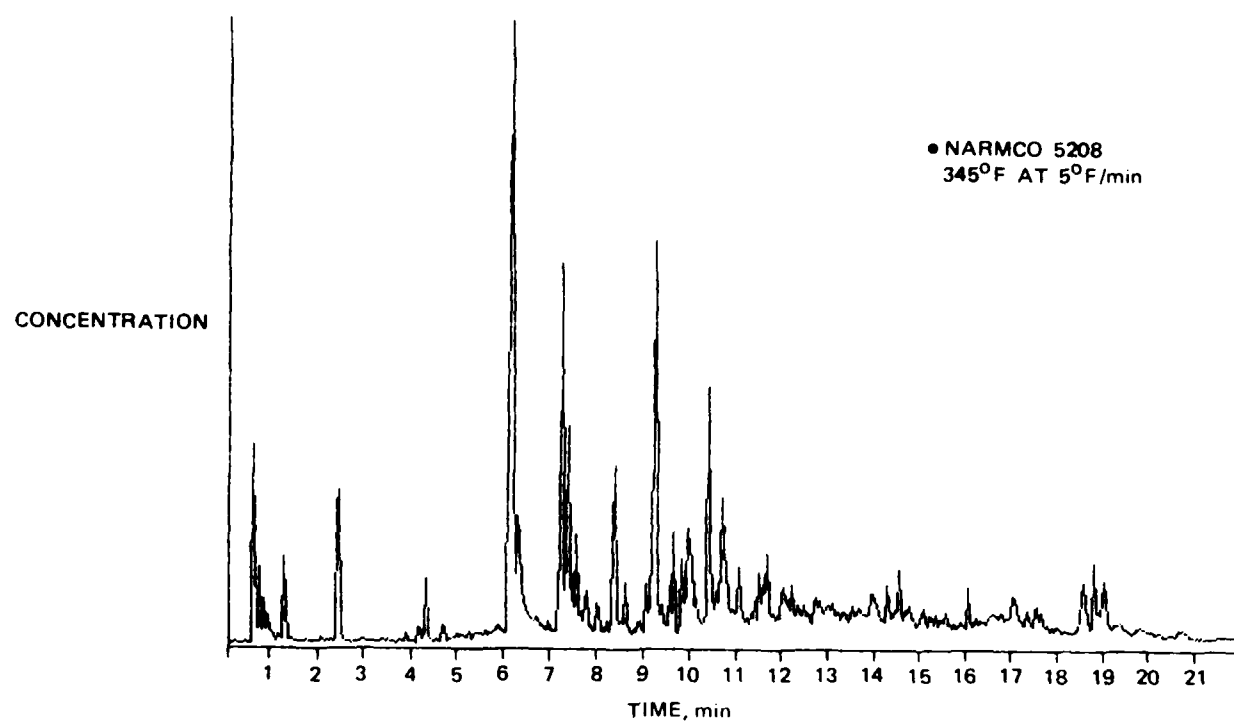
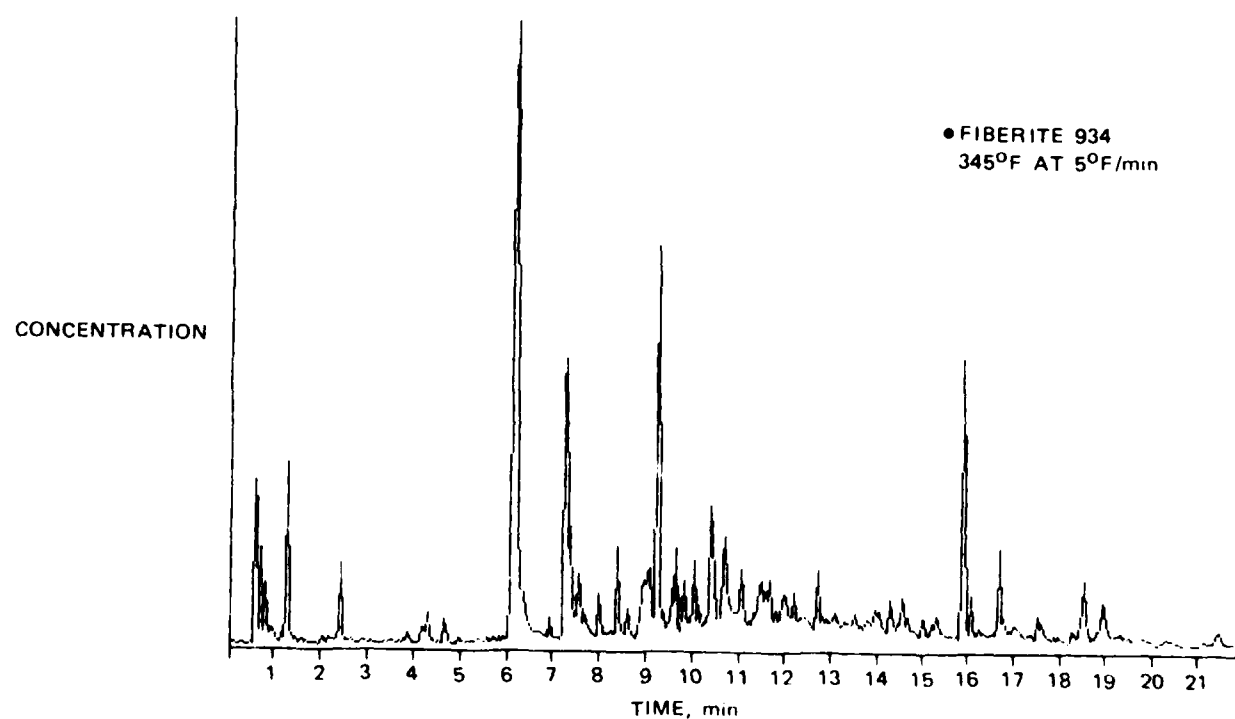
Figure 3-14. Pyrolysis Gas Chromatography (PGC) of Two Difficult Resin Systems

PGC requires samples of approximately 25-50 micrograms. Pyrolysis is accomplished at 1000°C. Typical PGC chromatograms are shown in Figure 3-14 for two commercial epoxy systems. The resulting PGC chromatogram can be used to identify the matrix resin by comparing to a reference fingerprint standard.

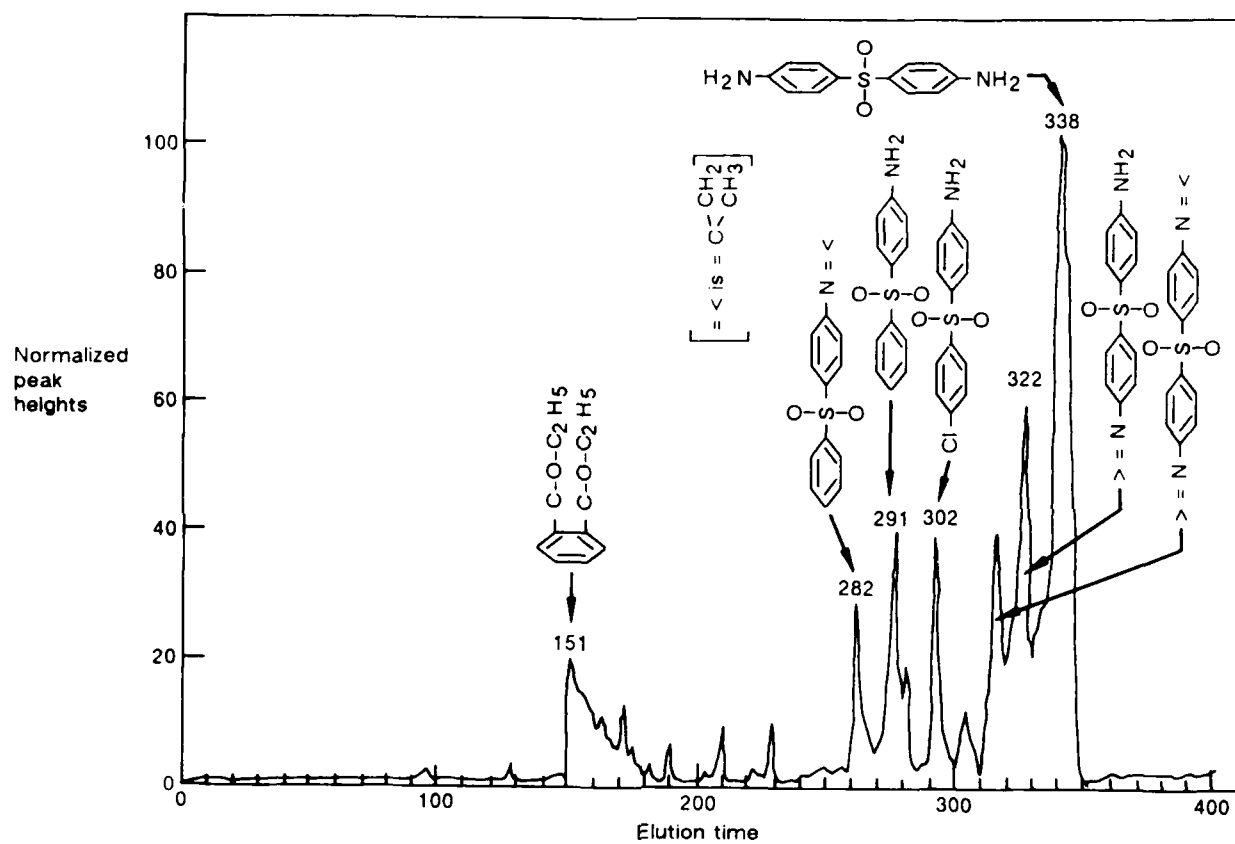
Figure 3-15. Gas Chromatography of DDS, Diaminodiphenyl Sulfone

assign component structure to chromatographic peaks, the pyrolysis products are passed through a capillary column directly into the mass spectrometer. A typical PGC chromatogram with MS peak assignments is shown in Figure 3-15 for DDS hardener. Identification of resin formulation can be accomplished using PGC/MS.

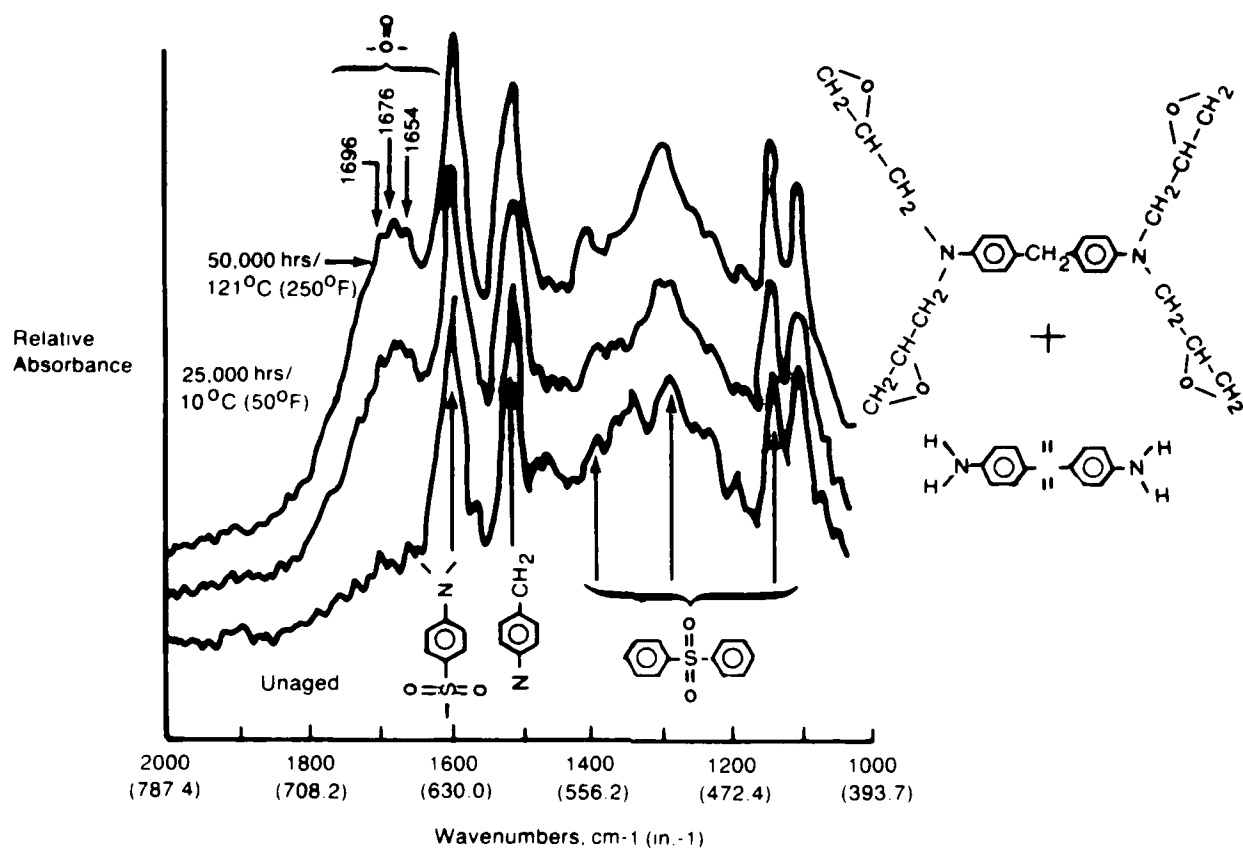
Figure 3-17. Drifts of Graphite-Epoxy (AS/3501-5) Composite Before and After Thermal Aging

Diffuse Reflectance Infrared Spectroscopy (DRIFTS)—This method permits direct measurement of the infrared spectrum from a cured composite resin. Infrared radiation is focused on the sample. The resulting diffusely scattered infrared radiation is collected with a large solid angle detector. The spectrum is interpreted as a normal IR spectrum would be; except that a number of potential artifacts due to variations in sample geometry, peak distortions and spectral interferences may occur. Figure 3-17 (ref 3) illustrates DRIFTS spectra of a composite before and after thermal aging where increasing oxidation with aging is observed. Note the increased absorbance levels at 1654 to 1696 nm.

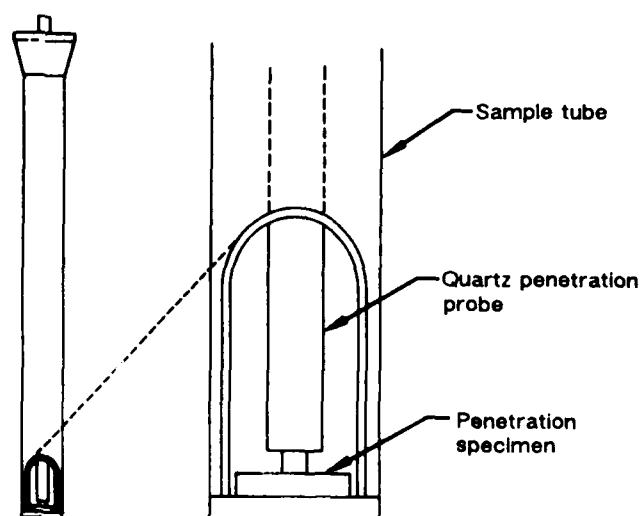
Penetration Method

Figure 3-18. Glass Transition Temperature Determination—TMA Penetration Test Setup

- **Penetration**—In this mode, a probe is placed on the side of a small rectangular specimen cut from the sample. Typically, a cubic shaped specimen with 0.1 to 0.15 inch for each dimension is used for this technique. This small sample size lowers the concern of thermal lag. The generation of any thermal lag between the temperature of the sample (which is uncontrolled) with that of the surrounding chamber (which is controlled) can affect data accuracy. For most samples, the direction of fiber orientation does not represent a critical parameter in this test since only relative dimensional measurements are being made, however placement of the probe directly on the carbon fibers instead of the epoxy resin may interfere with sharp definition of the glass transition. During the test, the specimen is situated as shown in Figure 3-18, heated at a controlled rate, typically 5° to 25°C/minute, and the glass transition temperature

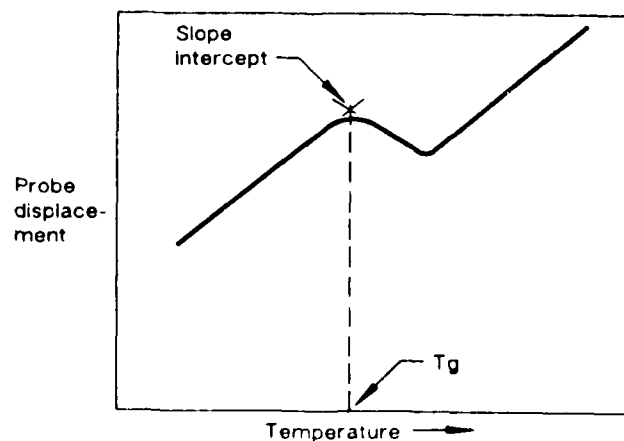
Figure 3-19. Glass Transition Temperature Determination—TMA Penetration Test Measurement

determined by a pronounced downward movement of the probe indicating matrix softening, Figure 3-19. Typically, several specimens from a part are characterized. The measured T_g can then be averaged to minimize errors due to specimen inhomogeneity on a small scale.

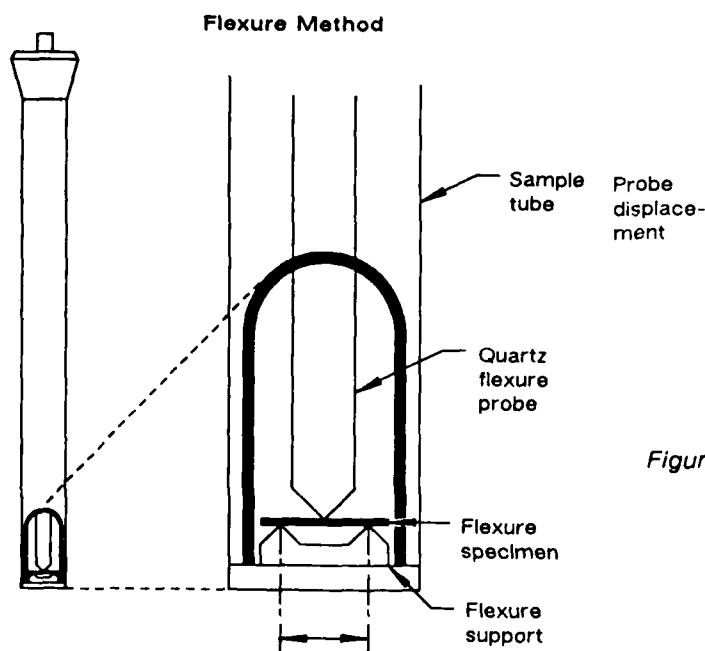
Figure 3-20. Glass Transition Temperature Determination—TMA Flexure Test Setup

- Flexure**—In this test mode, a rectangular sample 0.1 inch in width by 0.25 to 0.50 inch in length by 2 to 4 plies in thickness is placed in three point flexural stress within the test chamber as shown in Figure 3-20. With this configuration the probe measures beam deflection as a function of temperature. Again, as the transition temperature is reached the resin softens, the beam (specimen) deflects, and an inflection in the slope of the thermogram being generated occurs. Nominally, the heat-up rate is approximately 20°C/Minute with a probe load of 10 grams. A thermogram of a 177°C (350°F) epoxy system is presented in Figure 3-21, showing the tangents to the slope. The Tg is defined as the temperature at which the tangents intercept. Care should also be taken to not remove specimens from the laminate near a surface which has a different chemistry or cure temperature material attached. This includes adhesively bonded regions, potted areas or surfaces which have had surface prep fabric such as peel-ply.

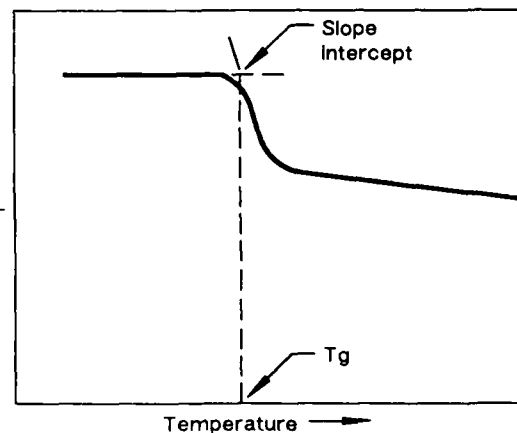
Figure 3-21. Glass Transition Temperature Determination—TMA Flexure Test Measurement

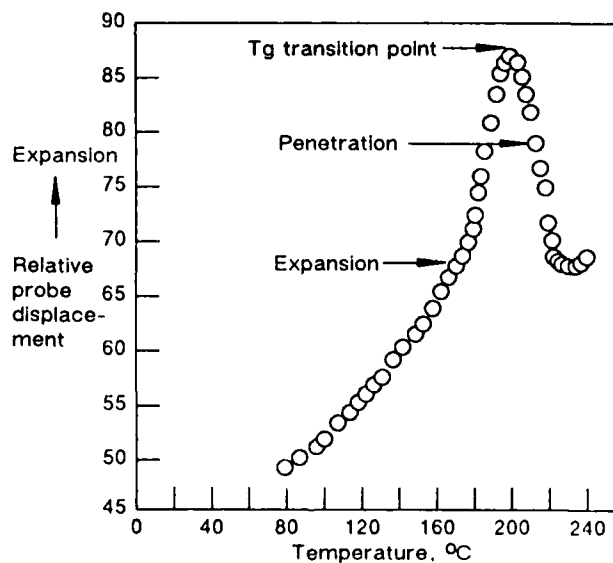
Figure 3-22. Determination of Tg by Expansion Method

- **Expansion**—This test is run in much the same manner as penetration, except a larger diameter probe is utilized to prevent penetration into the sample at the point of softening. As the specimen is heated, the resin is free to expand in the transverse or lateral direction. Since a distinct increase in the rate of thermal expansion normally occurs at the glass transition, the thermogram generated by this technique typically provides an additional method by which to determine the materials' glass transition (Figure 3-22). As in the penetration method, placement of the probe directly on carbon fibers may interfere with accurate Tg determination.

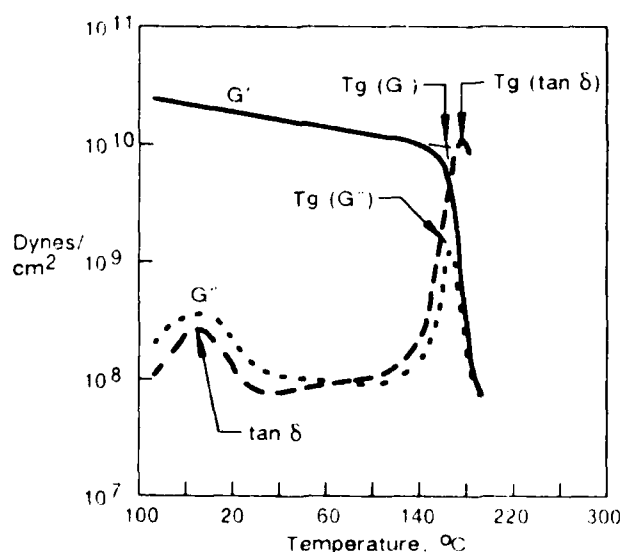
5-B70227-156

Figure 3-23. Typical DMA Plot for Cured Epoxy Showing Glass Transition Determination

Typical DMA data are shown in Figure 3-23. The glass transition temperature can be determined as the peak temperature of the high temperature transition in tangent delta or loss modulus or as the knee of the storage modulus curve.

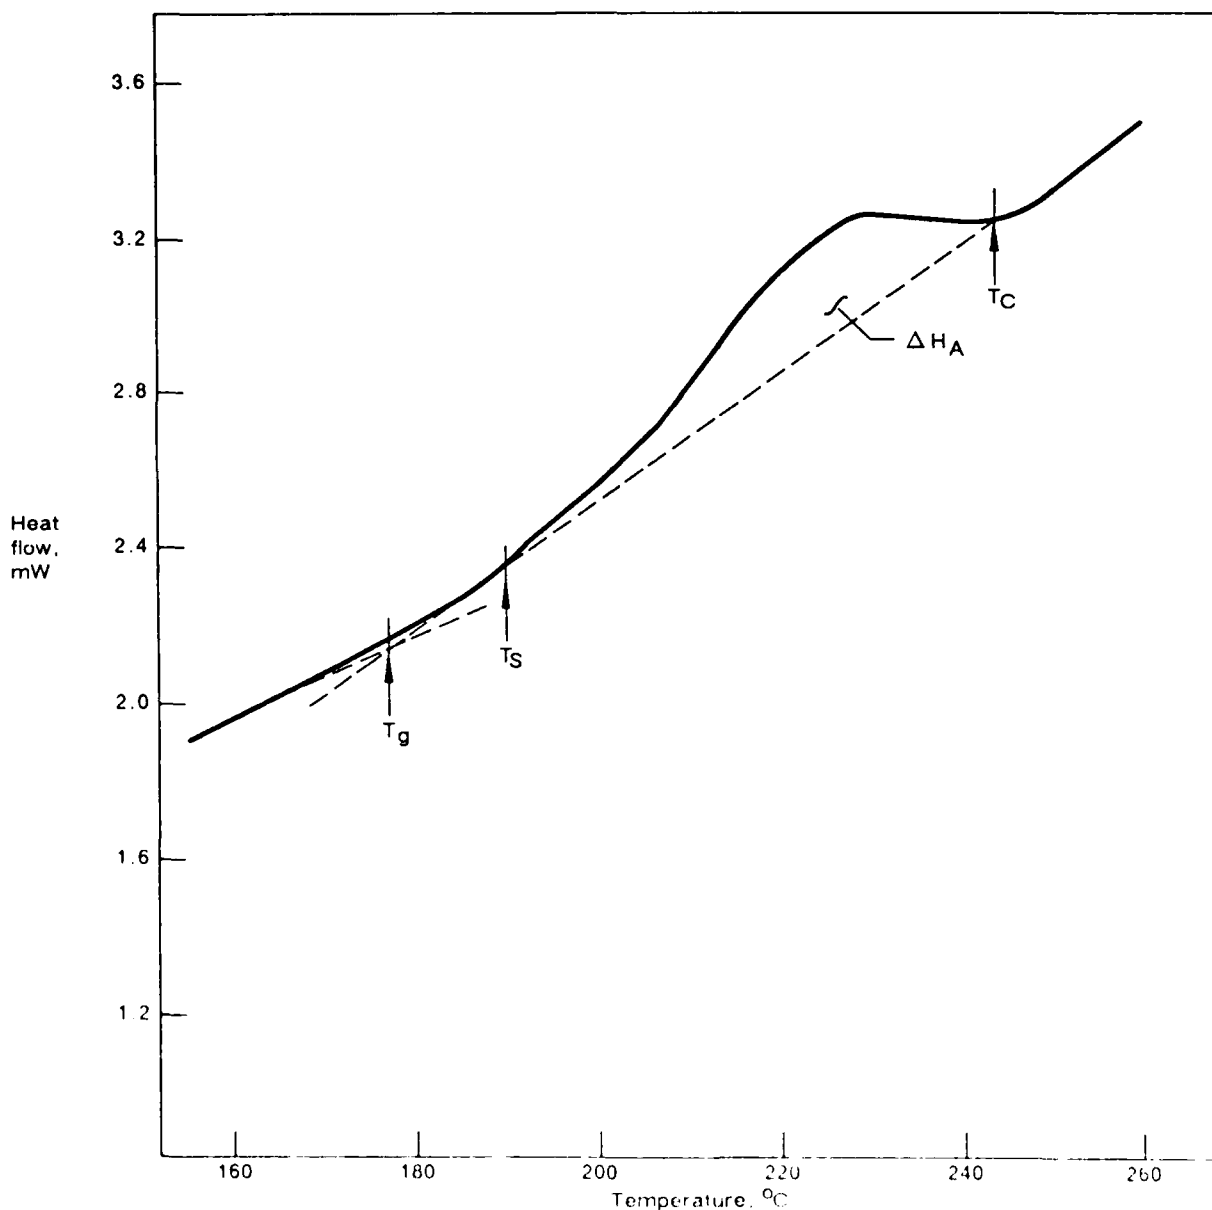
Figure 3-24 A Typical DSC Plot for Cured Epoxy Illustrating Determination of the T_g and Heat of Additional Reaction

A typical DSC thermogram for a cured epoxy is shown in Figure 3-24. The glass transition will appear as a change in the slope of the DSC thermogram. Determination of glass transition temperature using DSC is sometimes difficult because of the exotherm peaks due to additional reaction during the DSC test.

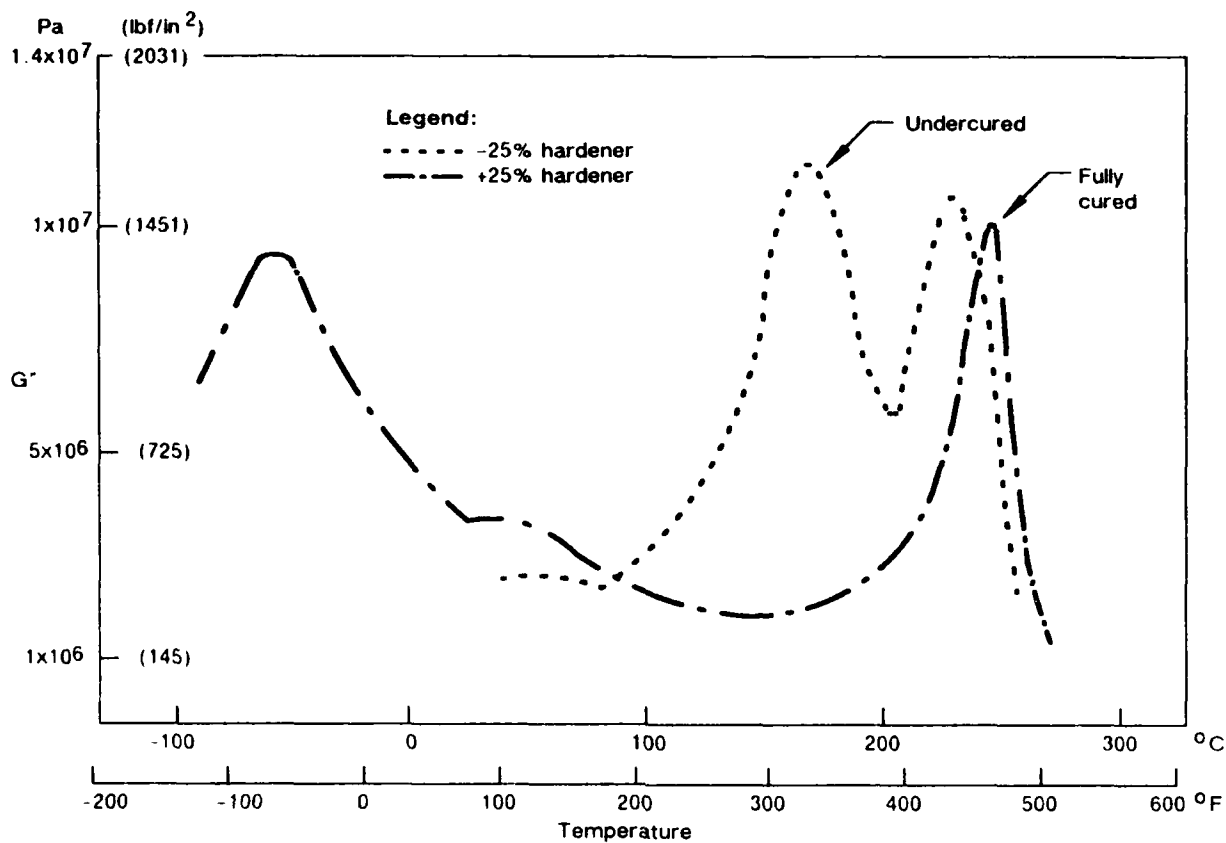
Frequency: 1 Hz

Figure 3-25. DMA Loss Modulus Versus Temperature Showing Effect of Undercure for Epoxy Resin

Dynamic Mechanical Analysis (DMA)—DMA can be used to detect undercure and moisture degradation of cured laminates. Experimental procedures as described in paragraph 3.1 are used. An undercured laminate will exhibit a double high temperature peak in tangent delta and loss modulus plus an initial loss with subsequent recovery of storage modulus as shown in Figure 3-25. The initial softening (increase in tangent delta, loss modulus; decrease in storage modulus) is attributed to the glass transition of the original under-

cured material. As the test temperature increases, the matrix undergoes further cure allowing a recovery of properties. The final softening is due to the glass transition of the fully cured material. Laminates with absorbed moisture exhibit a peak in tangent delta and loss modulus at approximately 100°C due to the increased activity of moisture at this temperature. The presence of this peak indicates significant absorbed moisture in the laminate.

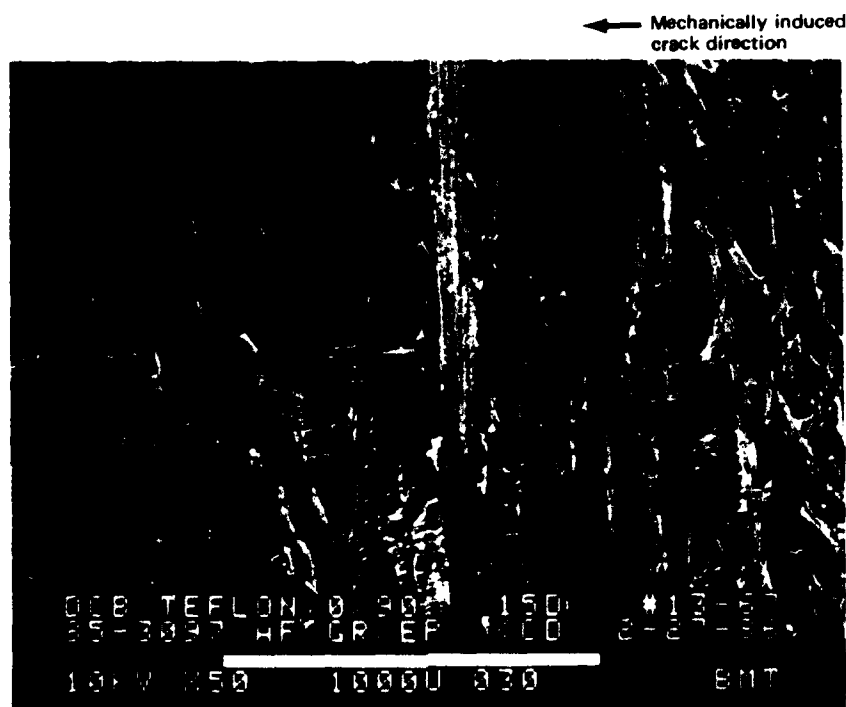
5-B70227-5

Figure 3-26. SEM Micrograph of a Teflon-Contaminated Tension Specimen

As illustrated in Figures 3-26, 3-27, and 3-28, contamination caused by Teflon paddle and Frekote release agent along the interlaminar ply interface exhibit inhomogeneous resin fracture as compared to a typical uncontaminated baseline fracture specimen illustrated in Figure 3-29. A second example of an isolated foreign particle inclusion, in Figure 3-30 illustrates the distinctive fracture surface asperity and crack initiation lines radiating from the particle. However, isolated particles will not significantly degrade the structural integrity of the composite. This is because the fibers already act as primary sites of crack initiation. As a result, low delamination strengths are expected and incorporated into the designs. Particulate contamination along these directions can be tolerated in moderate amounts without significantly affecting the performance.

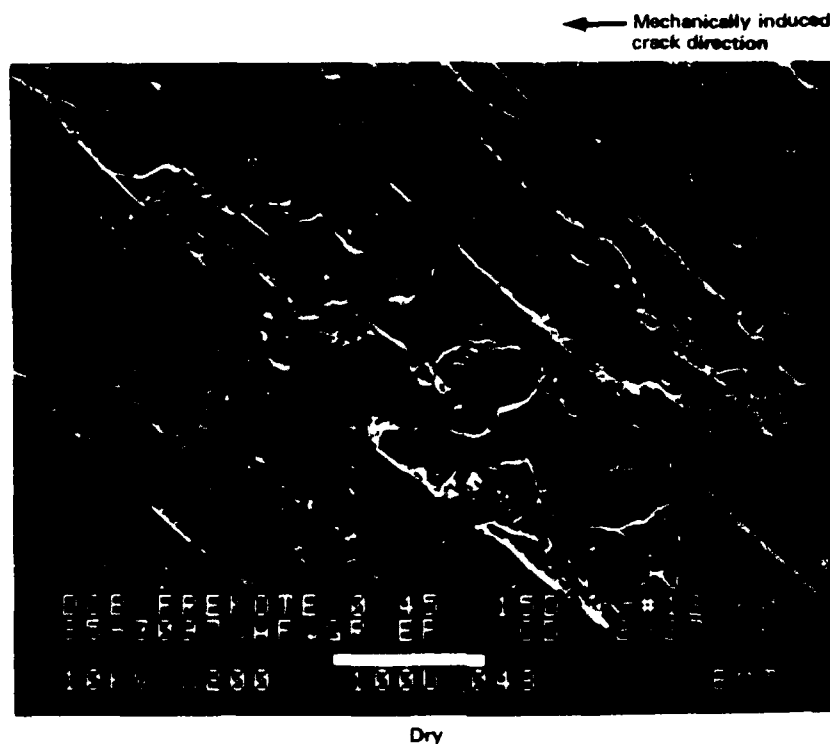
5-B70227-6

Figure 3-27. SEM Micrograph of a Frekote Release Agent Contaminated Tension Specimen (200X)

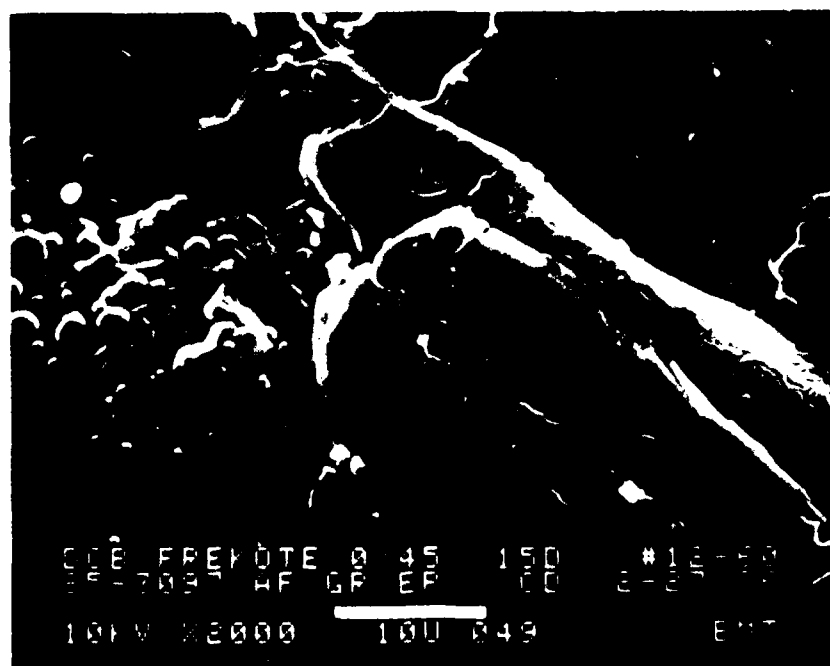
5-B70227-7

Figure 3-28. SEM Micrograph of a Frekote Release Agent Contaminated Tension Specimen (2000X)

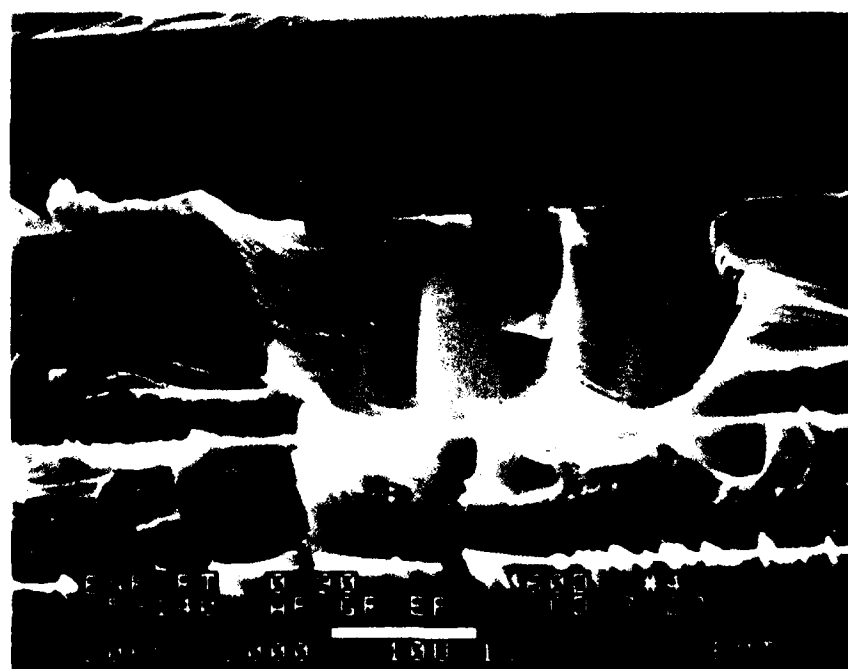
5-B70227-8

Figure 3-29. SEM Micrographs of a Typical Uncontaminated Fracture Specimen

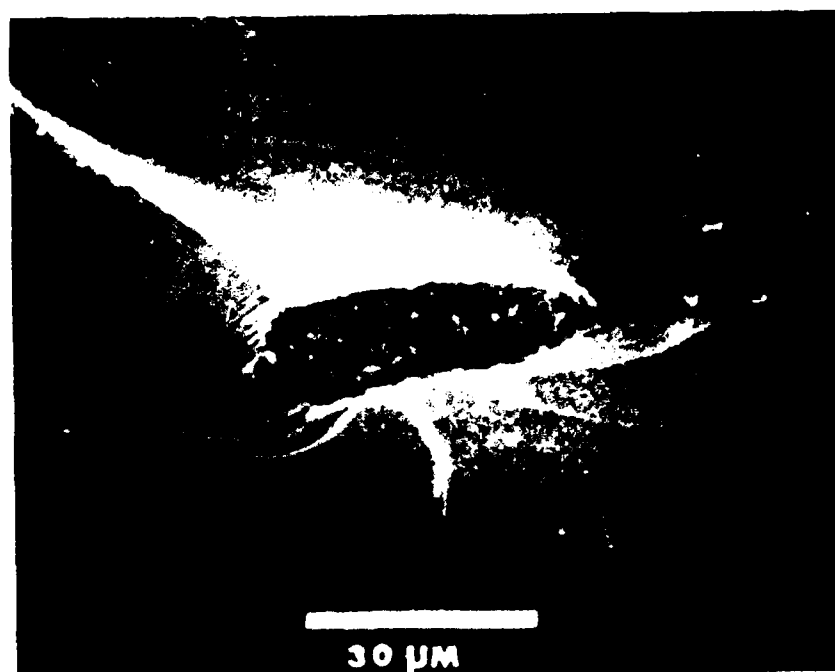
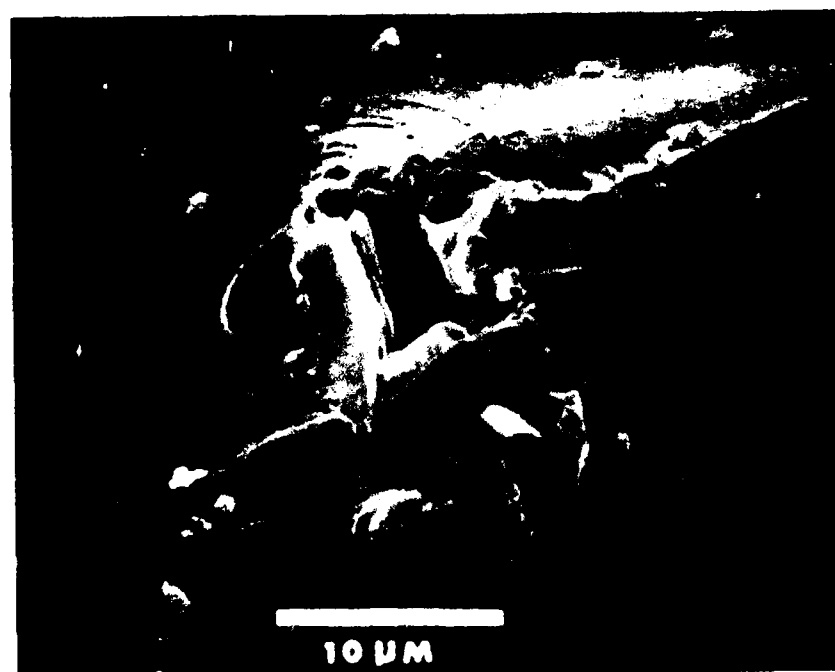
5-B70227-9

*Figure 3-30. SEM Micrographs of Foreign Particle Inclusions
Illustrating the Characteristic Fracture Surface
Asperity and Radiating Fracture Lines*

Special care must be taken to avoid confusing the post-failure surface debris on the fracture surface with foreign particle inclusions in the resin. By definition the surface debris will not initiate radiating fracture lines. This is especially a problem where the fracture surface has had a long environmental exposure or experienced in-service cyclic loading conditions. Caution should also be exercised when extensive mechanical cutting was required to extract the specimen from the failed component. Often the particle shape can lead to identification of the contamination source where the particulate contains fractured carbon fibers and the source could be traced to machining debris. Another concern in examining a resin system with particles on the fracture surface is that the resin may have intentional particle additions (or phases) which improve properties or manufacturing characteristics. If there is a suspicion that the resin system may have been modified in this way, the analyst must prepare a lab fractured specimen for SEM examination as a reference fracture surface.
